Risk Assessment and Safety Precautions for Construction Site Scaffolding

Ajibola Ibrahim Quadri^{1*}, Olaolu George Fadugba²

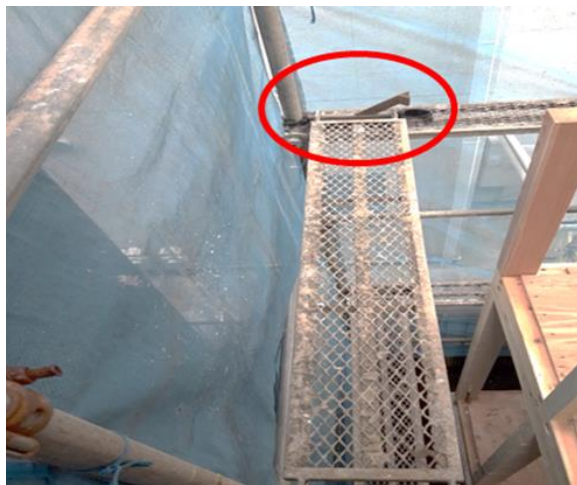
The authors presented different kinds of hazards associated with falls from heights as well as the collapse of scaffolding due to human error/negligence, and structural problem collated randomly from different construction and rehabilitation sites. Figure 2 (left side) shows a 25 cm compression-tension support clamp lopsidedly placed longitudinally on a half-width size mesh to support a full-width size mesh along the transverse direction, this was done to complete a lift of the scaffold section in an ongoing construction of a 3-story wooden building. A half-width size mesh was adopted due to the limited space available for work, however, the connector seat for the half-width mesh could not agree with the full width one. The personnel thus improvised by using the clamp. This and others are some of the human errors that led to fall from heights on-site when inexperienced people handle the scaffold erection. Figure 2 (right side) is the rehabilitation of two adjacent 4-story buildings.

Fig. 2. Improper placement of support clamp (left) and corroded scaffold elements.

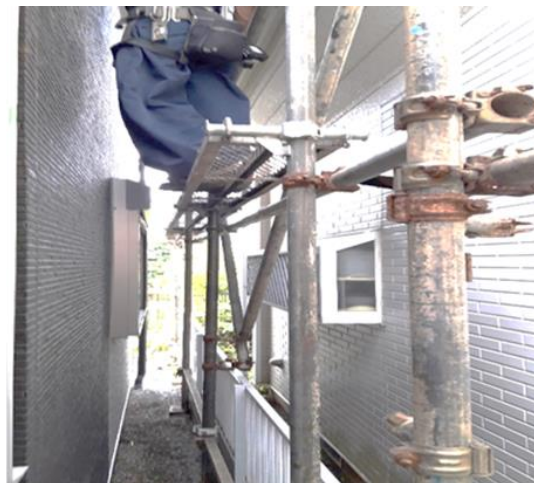
Here, some of the clamps and scaffold elements used are corroded due to the long-term exposure to the environment and constant usage without proper care. The corroded elements are vulnerable under constant loading, and strong ground motion can increase the stress action beyond their carrying capacity. In this case, the global stability of the entire system is affected, corrosion-fatigue crack propagation could be triggered while the structure failed without prior warning.

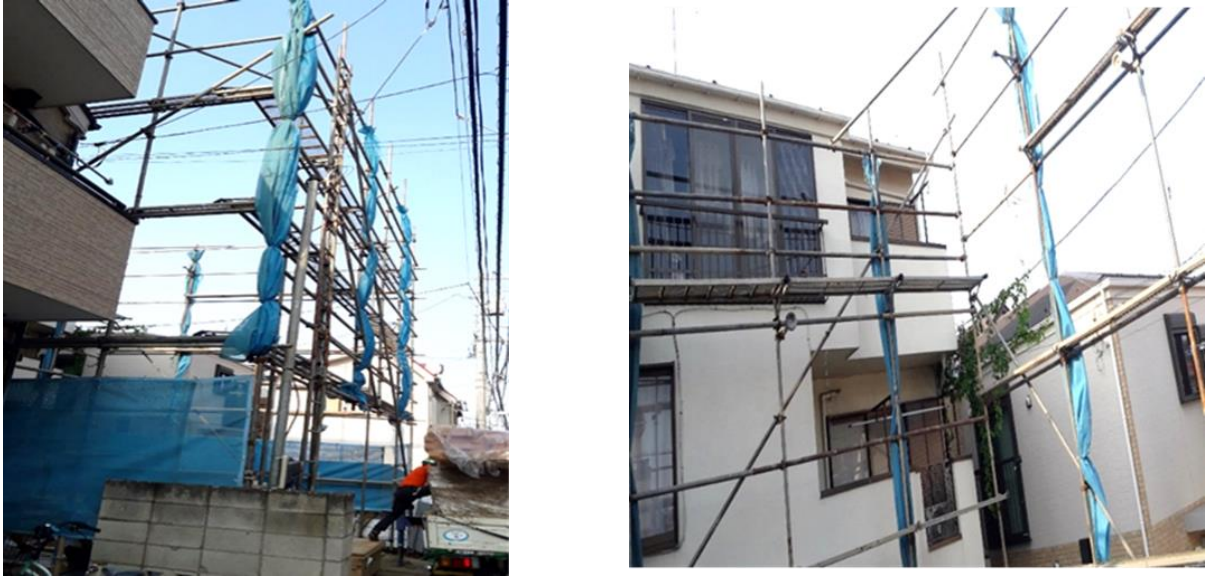
In Figure 3, the modular assemblage of scaffolding for the construction of a 3-story building (left) and 2-story building (right) are shown. The guard rails in both cases are absent in the module. The landing platform to support heavy materials and workers at some section is absent in the case of the 2-story building scaffolding, the reason for this is not clear to the author. However, double longitudinal 4 meters pipes are clamped together to complete the floor lift in this section. This practice is common when there is a shortage of scaffolding components.

Fig. 3. Absence of scaffold insulator (left) and guard rails (right).

Furthermore, the 3-story scaffolding is close to the electricity distribution high tension cable. Japan international Centre for occupational safety and health (JICOSH) guidelines recommended the use of insulators to avoid electrocution during high wind. The insulator is overlooked by many scaffolding companies when there are favorable seasonal climate conditions. Several traditional designs of scaffolds in Japan have been on how to make it stronger because of the prevalent natural disaster (earthquake, storm, and hurricane, etc.), safety, however, efficiency of scaffolding erection are sometimes jeopardized because it is a temporal structure. Figure 4 is a 27 meters building mainly used for offices, is situated in Tokyo prefecture about 1 kilometer from the Pacific Ocean. The top surface is to be worked on but due to the limited access to the top, scaffolding was

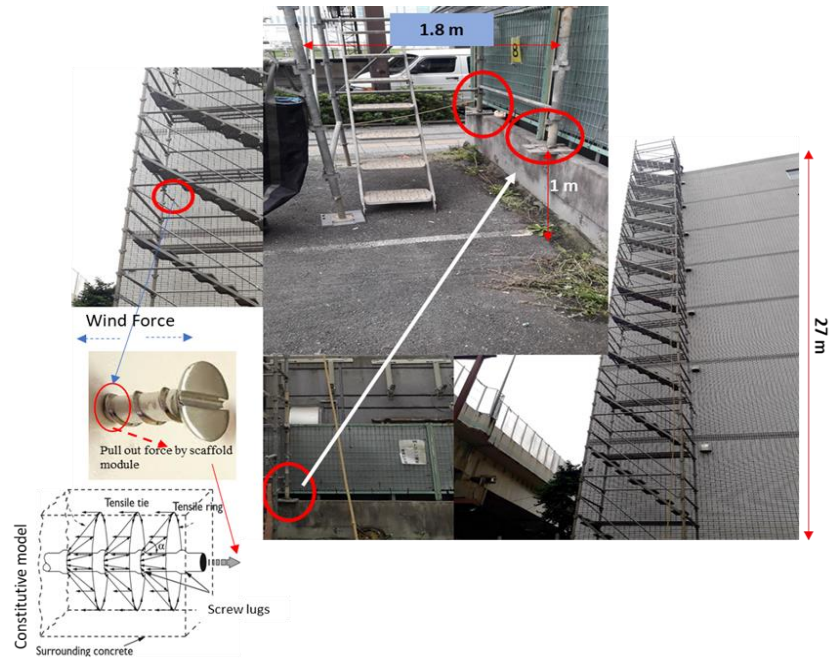
erected as quick access to transport some materials to be used. The distance between the erected ground poles connected by the lower transform to make the scaffold is 1.8 meters, anchored screws are used at every 3 meters to fasten the scaffold setup with the wall for more strength. However, two of the scaffold legs are erected on the fence, making the base plate structurally unstable. During strong wind or ground motion occasion by an earthquake, there is the possibility of a pullout of the anchored screws from the concrete wall, coupled with the overturning moment due to the improper placement of the base plates. Furthermore, the major highway around the Tokyo metropolitan is just 15 meters beside the 27 meters scaffold, hence, the chances of an accident occurring due to no safety erection are high.

Fig. 4. Renovation of the roof of 27 meters high building in Tokyo.
