## Experimental Study of Reinforced Concrete Frame Rehabilitated by Concentric and Eccentric Bracing

**A. Hemmati<sup>1\*</sup>, A. Kheyroddin<sup>2</sup> and M. Farzad<sup>3</sup>**

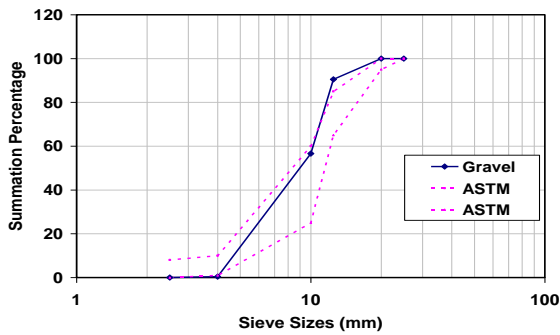
Fig. 1. Particle size curve of coarse aggregates.

Coarse aggregate with maximum size of 19 mm, fineness modulus of 7.38, water absorption ratio of 0.6% and specific gravity of 2.61 was applied for experimental work. Natural river sand with fineness modulus of 2.69, water absorption ratio of 0.8% and specific gravity of 2.55 was used as well. Portland cement type II was used for this experimental study. Particle size curves of the used aggregates associated with the

permitted ranges of ASTM are portrayed in Figures 1 and 2.

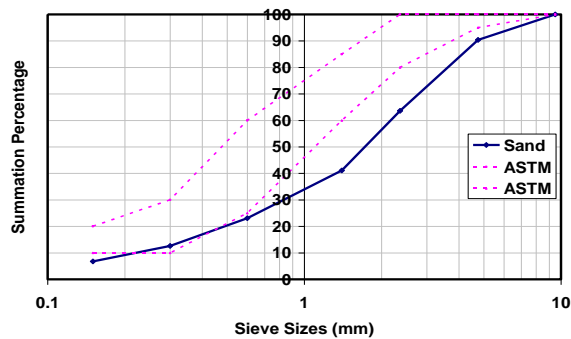
Fig. 2. Particle size curve of fine aggregates.

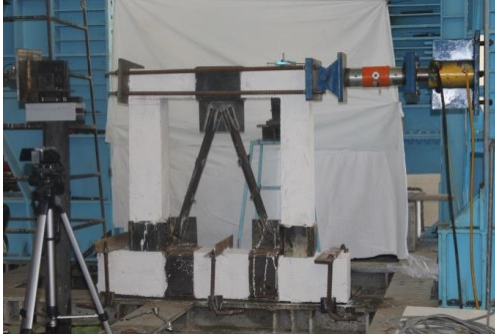
**Fig. 6.** Test set up.

Test set up is shown in Figure 6. The loading protocol is also presented in Figure 7 [29].

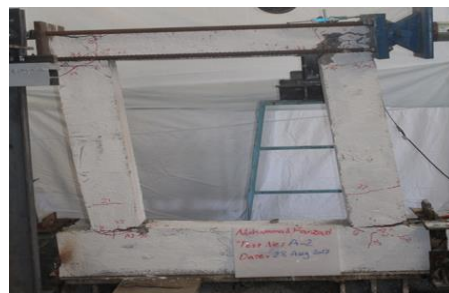
**Fig. 10.** RC frame at the end of loading.

lateral load, most parts of the concrete around the critical sections (around the connections) cracked and crushed and finally, the frame carried the lateral load of about 104 kN and displacement of about 44 mm. The condition of the RC frame at the end of loading is presented in Figure 10.

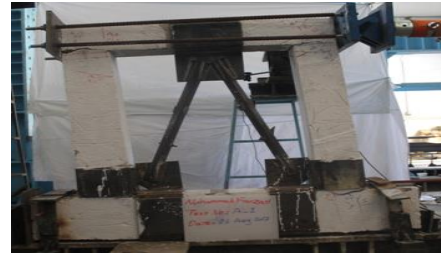
**Fig. 14.** CBF specimen at the end of loading.

The first and second cracks were appeared at the lateral load and displacement of  $41.6 \text{ kN}$  and  $7 \text{ mm}$  respectively. These initial cracks occurred at the external parts of the left and right columns, near the beam-column junction. The third and fourth inclined cracks appeared at the both columns top near the column-foundation connections. These initial cracks are exhibited in Figure 12. Further loading caused the cracking to spread at the beam-column junctions and column-foundation connections of the concentric braced frame as displayed in Figure 13. With increasing lateral load, most parts of the concrete around the critical section (around the connections) cracked and crushed and finally, the frame carried the lateral load of about  $220 \text{ kN}$  and displacement of about  $42.8 \text{ mm}$ . The condition of the CBF frame at the end of loading is exhibited in Figure 14.

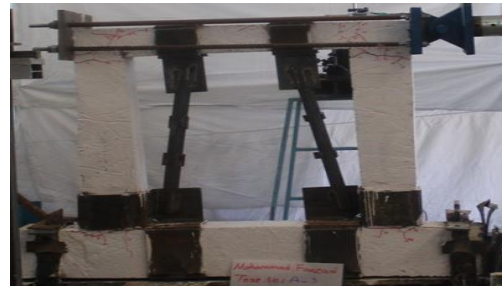
**Fig. 18.** EBF at the end of loading.

The first and second inclined cracks were appeared at the lateral load and displacement of  $40\text{ kN}$  and  $7.2\text{ mm}$  respectively. These initial cracks occurred at the beam-column joint and spread toward the beam. The third and fourth inclined cracks appeared at the external part of the right column, near the beam-column junction. These initial cracks are highlighted in Figure 16. Further loading caused the cracking to spread at the beam-column junctions and column-foundation connections of the EBF frame, as demonstrated in Figure 17. With increasing lateral load, most parts of the concrete around the critical section (around the connections) cracked and crushed and finally, the frame carried the lateral load of about  $198\text{ kN}$  and displacement of about  $51\text{ mm}$ . The condition of the EBF frame at the end of loading is displayed in Figure 18.
