## Performance Evaluation of a Trunk-A Road in North Central Nigeria

### ABSTRACT

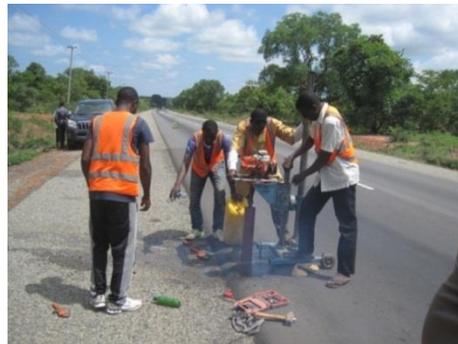
Fig. 2. Coring through the pavement structure..

- Coring through the pavement structure (Fig. 2);
- Collection of core samples of asphalt (Fig. 3);
- Evaluation of thicknesses of asphalt, base and sub-base courses;
- Dynamic Cone Penetration (DCP) test (Fig. 4) to infer CBR values of Base, Sub-base and Sub-grade.

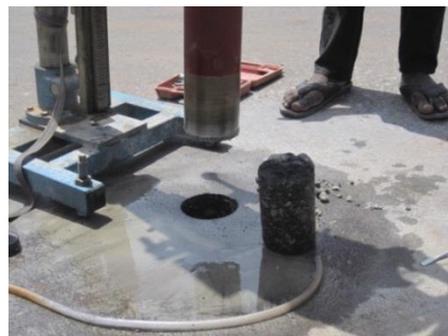
Fig. 3. Collection of core samples of asphalt.

Laboratory tests, carried out on the cored asphaltic samples included Marshall Stability test, bulk density test, bitumen content test, flow test, void ratio test, determination of percentage voids filled with bitumen and aggregate grading test. Marshall Stability and flow of asphalt mixtures tests were conducted according to ASTM D6927-15 [37], while bitumen content extraction test was carried out using Centrifuge Extraction Procedure, as highlighted by ASTM D2172/D2172M-11 [37].

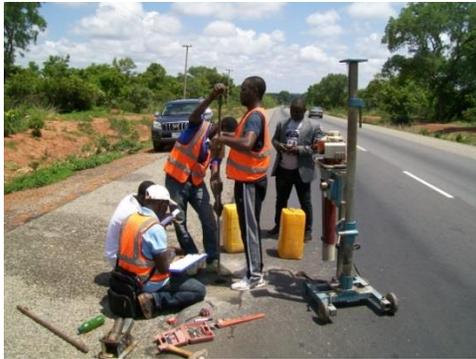
In conducting the DCP test, a light weight 8kg rammer, 60-degree cone head Dynamic Penetrometer was used. The number of blows for each 10cm penetration was recorded, and averages of number of the blows were used to calculate the CBR of the pavement structures. In estimating CBR of the pavement structures, the correlation (equation 1) advanced by TRL [36] was used.

Fig. 4. Dynamic Cone Penetration test.

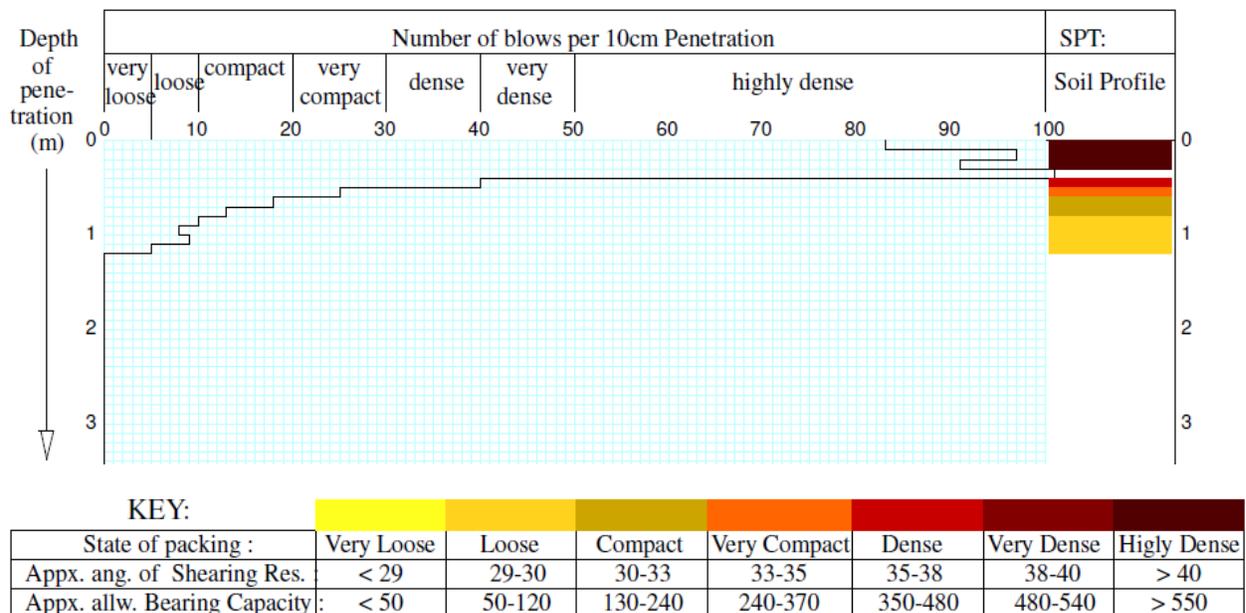
At the first test location (CH 18+600), repair work was observed to have been carried out at this location. Moderate fattening-up of bitumen and depression of the wearing course was noticed. Coring revealed thickness of the asphaltic concrete on this portion of the road to be 95mm. 200mm thick crushed stone base was observed to have been used at this location, while the sub-base course was of lateritic soil material, compacted to 200mm thick. The sub-grade material at this point was observed to be reddish sandy lateritic soil. The DCP result (Fig. 5) showed the base and sub-base courses at this location to be highly dense with average CBR values of 180 and 193% respectively, while the sub-grade, up to 600mm thick, ranges from dense to loose material with an average CBR value of 35% (Table 1).

Fig. 5. DCPT Result for test location one (CH 18+600).

**Table 1.** Inferred CBR values of pavement structures at test location one (CH 18+600).
