Seismic Retrofit of a Historical Building in Tehran University Museum Using FRP Technology and Steel Jacketing

Omid Rezaifar^{1*}, Adel Younesi², Majid Gholhaki¹

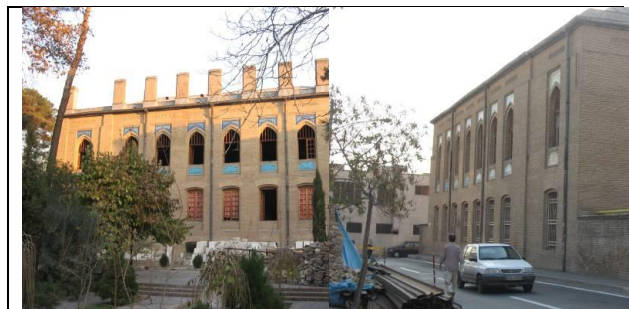
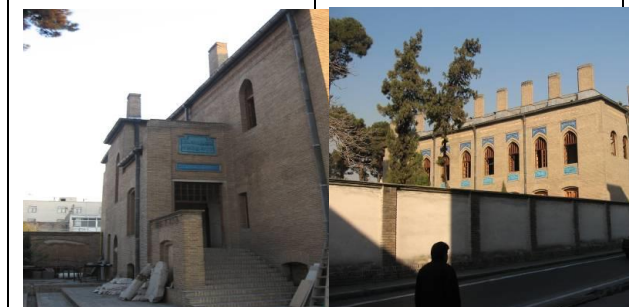
Figure 3. Building pictures

South elevation

North elevation

West elevation

East elevation

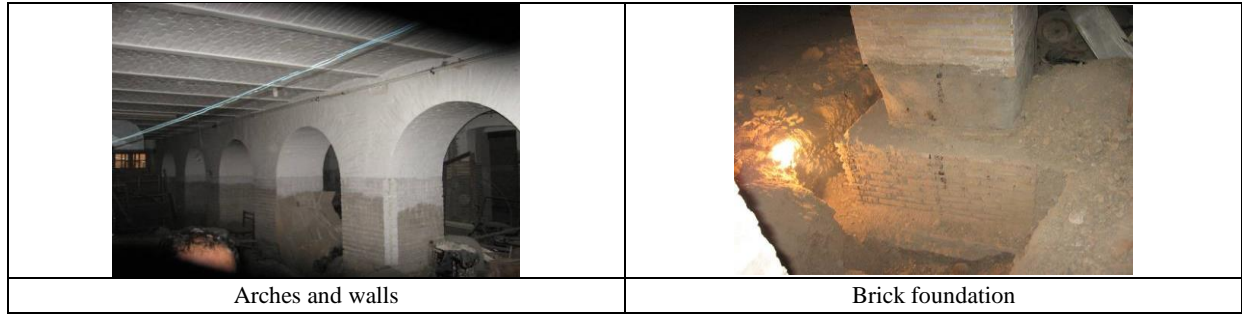
Figure 7. Foundation and walls detail

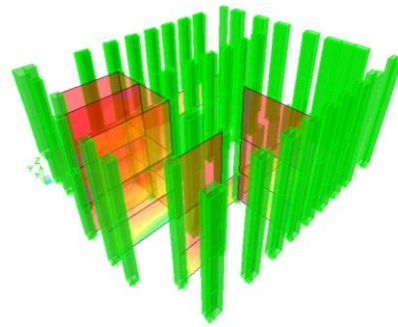
Figure 16. Stresses result of analysis under lateral loading

structure as a good special rehabilitated building under high level of earthquake vibration. Results in analysis show that stress after rehabilitation is reduced in walls, and integrity of the system leads it to be a complete system with excellent distributing of lateral forces. Figure 15 is modal deformation of structure that improved and gets higher value in compare with existing building. Figure 16 shows that stresses is reduced by this FRP bounding up to 50 percent, this strategy of rehabilitation constrains the drifts and cracks during shakes, and this purpose is very necessary for this historical building. FRP sheets and Steel jacketing make a more stiffened and ductile resistant system.
