## Risk Assessment and Challenges Faced in Repairs and Rehabilitation of Dilapidated Buildings

**Khan Sahil Waquar<sup>1</sup>, Karthik Nagarajan<sup>2</sup>, Raju Narwade<sup>2</sup>**

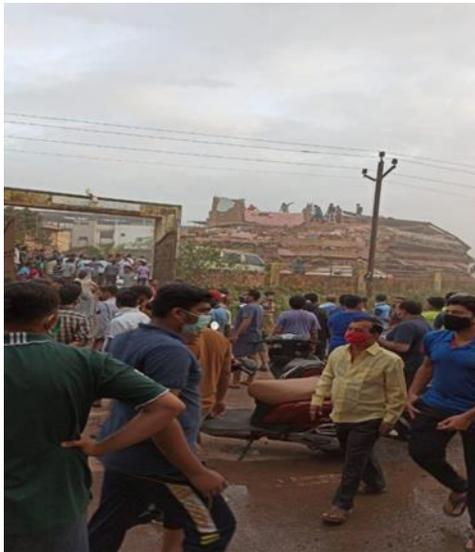
**Fig. 2.** The collapse of Tarique garden building in Mahad Maharashtra, India.

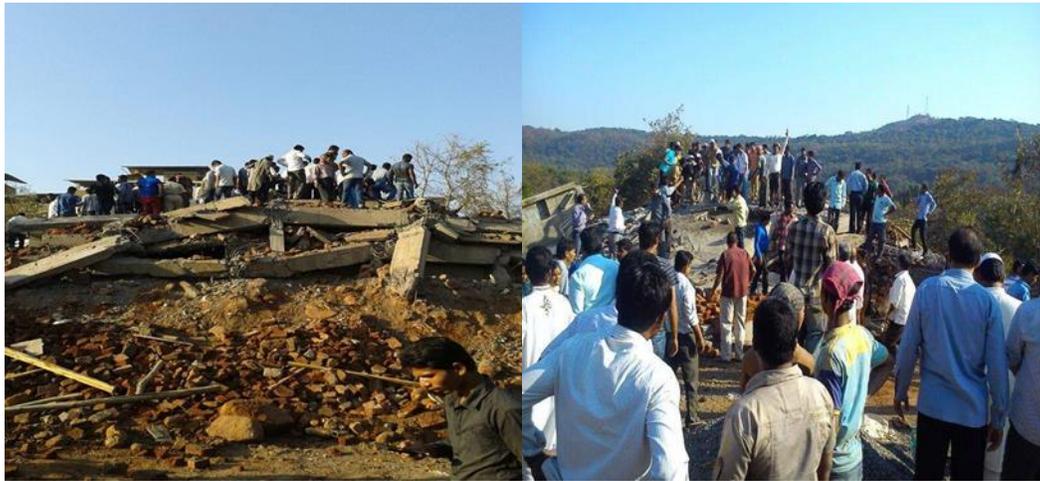
After a detailed study about the history of the research area, we found an incident of collapse of an under-construction building at Mahad-Naka area in khed town, which is also our research area in this paper in 2014, caused the death of one labor and injuries to 9 labors. The leading cause of the collapse was poor engineering and bad artistry where the quality of the material used was below the code, the sand used was not sieved, curing of the concrete members were not performed correctly, and the work was done without any proper supervision [42].

Fig. 4. The collapse of an under-construction building in khed city in the year 2014.[43].

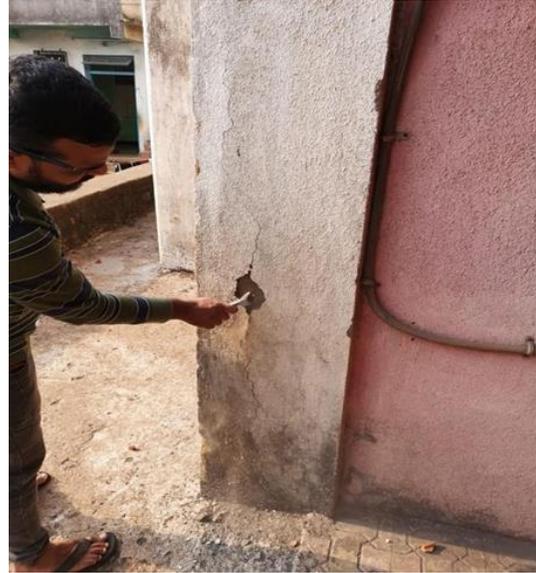
**Fig. 6.** Visiting building for inspection while checking column.

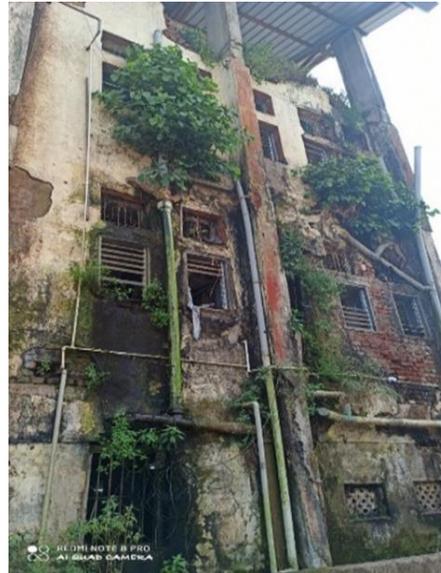
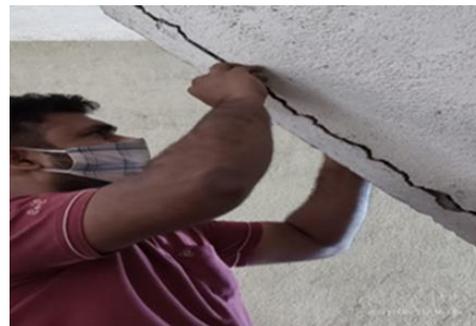
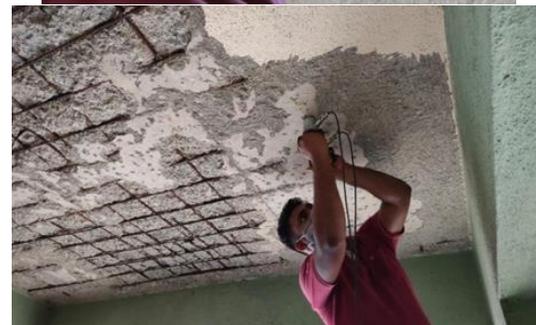
As discussed in methodology and following methodology as flow chart shown in Figure 5, these are outcomes of the data after field research. Nature's beauty in the Konkan region with its essential location and tourist attractions has made khed municipal area develop in the past 20 years where 300 buildings built. During the study, 140 buildings out of 300 registered as societies under the municipal council of khed were moderately done. However, these buildings were not issued notices to carry out audit work. Thus after the detailed study was done, the submission of findings was handed to the chief officer of the khed municipal council, where these buildings should be registered as early as possible as requested. Out of the remaining buildings, the owner's/societies members were approached about the detailed study to be done. It became apparent that out of 160 buildings, 89 owners/societies questioned what would khed Nagar Parishad do if they don't carry out survey or audit work. Thus similar status report was submitted to the chief officer of the khed municipal council. Local conditions and parameters were considered for surveying 71 buildings, and an assessment of risks was done to them. The on-field survey was done where the study of Nagar Palika / khed municipal building was done by visual inspection, and photographs were recorded as shown in Figure 6. The present conditions were noted, as shown in Figure 7.

**Fig. 7.** shows building conditions currently. (NDT Testing) An ultrasonic pulse velocity test.

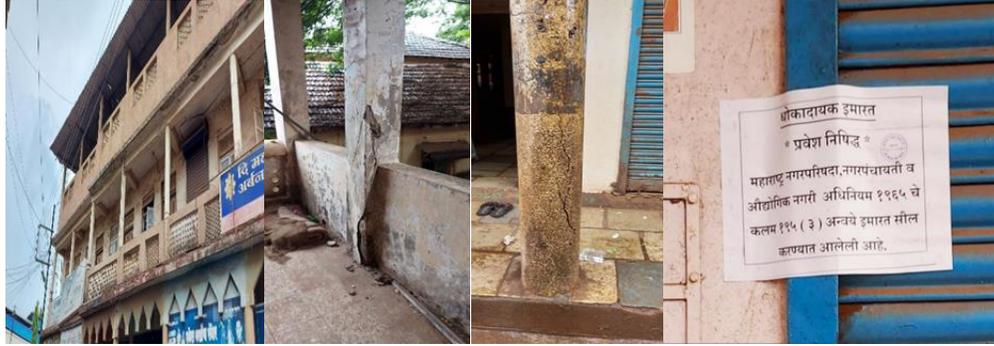
**Fig. 9.** shows the authorities' seal where the building is declared unfit to use under the C -3 category where entry of any person is not allowed (Dangerous building- entry restricted) written on the seal of the paper in Devanagari or Marathi script.

Numerous efforts were taken which were seen fruitful, and research was found successful when the municipal council found this topic very much sensitive, buildings were ordered to do structural audits to which the authorities issued notices to the buildings where they were sealed and made vacant, which was not the case earlier which is shown in figure 9.
