Risk Assessment and Safety Precautions for Construction Site Scaffolding

Ajibola Ibrahim Quadri^{1*}, Olaolu George Fadugba²

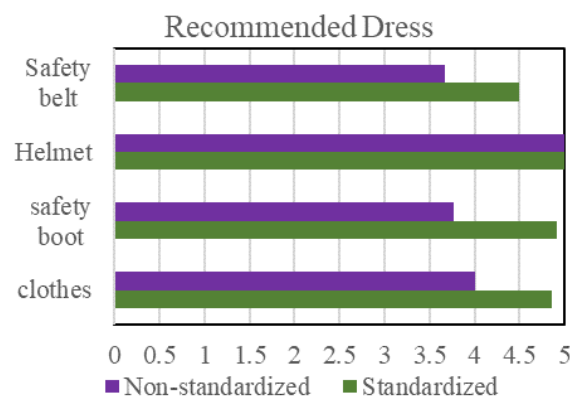
Fig. 5. Position of the Dress code.

As can be seen in Figure 5, the standardized recommended dress scored over 4.5 points except for the safety belts with 4.5 points. Non-standardized scored below 4.5 except for the helmet which scores exactly 5 points together with that of standardized. This points to the importance of protecting the head from unforeseen incidence such as falling

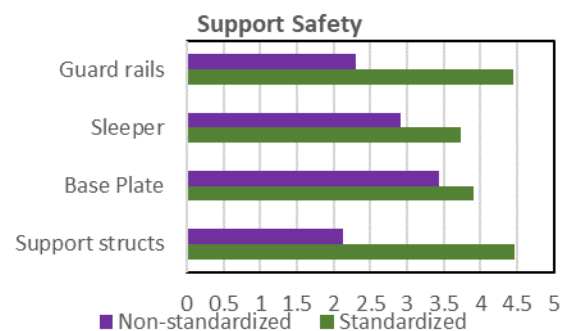
Fig. 6. Position of support safety.

As regards support safety, when the sleepers are necessary, it was ensured that they are not in a bad state. The guard rail is one of the important elements of the scaffold components, we took into consideration their presence in every scaffold lift and in the right position. We also checked the placement of the base plates appropriately and took the assessment in the right manner by ensuring

their proper position. As for the support struts, we ensured they are used for their intended purpose before taken the assessment and they are positioned correctly. Figure 6 is presented to show the safety support level of the scaffold module. The standardized scaffolding score averagely below 4.5 points while the non-standardized scaffolding score below 3.5 points with struts support having an average of 2.12 points, this is because most of the work examined under non-standardized scaffolding did not make use of the support struts. Table 4 shows the measure of dispersion under the support safety category, the non-standardized scaffolding is more disperse away from the average value compare with the standardized type as indicated by the standard deviation, SD, of the considered items.

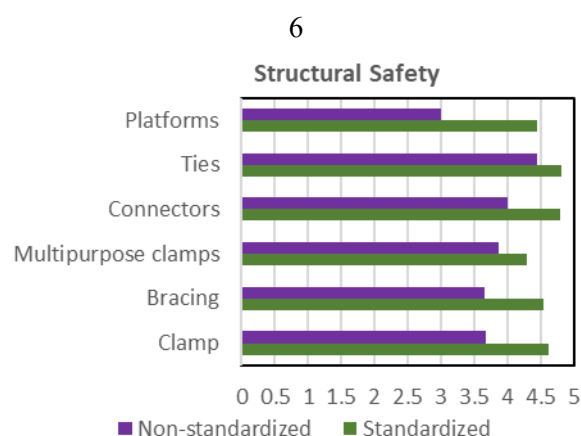
**Fig. 7.** Position of structural safety.

As far as the structural safety is concerned, we took into account the best possible way when at least each of the scaffold modules at the same or different height have diagonal or frame brace installed, and when the scaffold lift had guardrail in the appropriate position. As for the connectors, we checked that they are well connected with poles and well fastened together. Multipurpose clamps (swivel coupler) and ordinary clamps serve different purpose. The multipurpose clamps can connect horizontal guard rails and diagonal bracing together while the ordinary clamps connect the vertical poles with the guard rails. We examined the correct positioning. We further carefully examined the best position when all the scaffold modules had platforms not less than the minimum width recommended and appropriately secured to the framework. On the level of structural safety, the platforms and multipurpose clamps scored averagely below 4.5 points under the standardized scaffolding type, while the rest of the items scored above 4.5 points as presented in Figure 7. Ties have the highest points under the non-standardized scaffolding with an average value of 4.45. It can be seen in Table 5 that the dispersion from the average values of all the items for the category of both the standardized and non-standardized are almost equivalent except for the ties

which have SD of 0.21 for the standardized and 0.45 for non-standardized scaffolding.

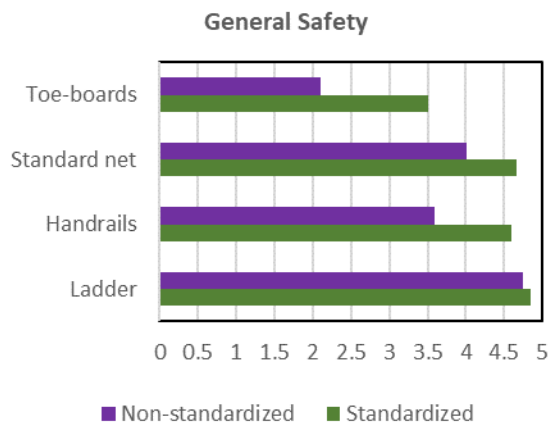
Fig. 8. Position of general safety.

The general safety of some of the scaffold modules was also investigated, ladder existence at each landing flight was ensured for evaluation and its presence on every scaffolding story up to the top was ascertained. The presence of the handrails was examined both along the ladder and at the necessary section on the setup and are well-positioned. The presence of the toe-board was also considered on every scaffold story up to the final height and in the correct position laterally placed on the scaffold. As for the standard net, it was examined that it serves its purpose by ensuring protection and are well tightened to the poles in the correct position. Ladder occupied the highest average point among the standardized types of scaffolding component with the lowest dispersion from the average, as presented in Figure 8, whereas the toe-boards with the lowest average point has the highest spread away from the mean. The same deviation is observed under the non-standardized type of scaffolding as shown in Table 6.
